3D Case Study 1

Building Issue – Leaking Roof with Difficult Accessibility Roofing

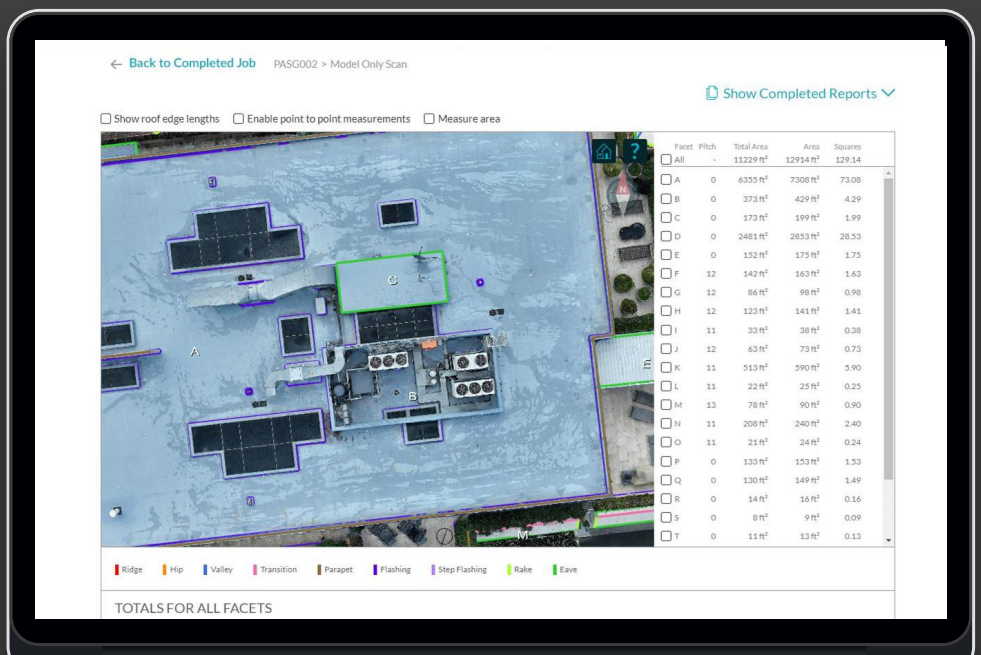
*This image illustrates the pitch of the roof and its attributes.

- Better understanding of the roof pitch to identify where the lack of fall was contributing to water ingress.

There was no fall to the roof into drainage points. This caused water pooling throughout the roof with the breakdown of the roof's membrane causing water ingress.

The roof cappings were pooling water and were not at the required minimum 3 degree angle.
